## **Historic Structure Assessment for Building 839, Carlisle Barracks**

Carlisle, Pennsylvania

October 2017

Final report

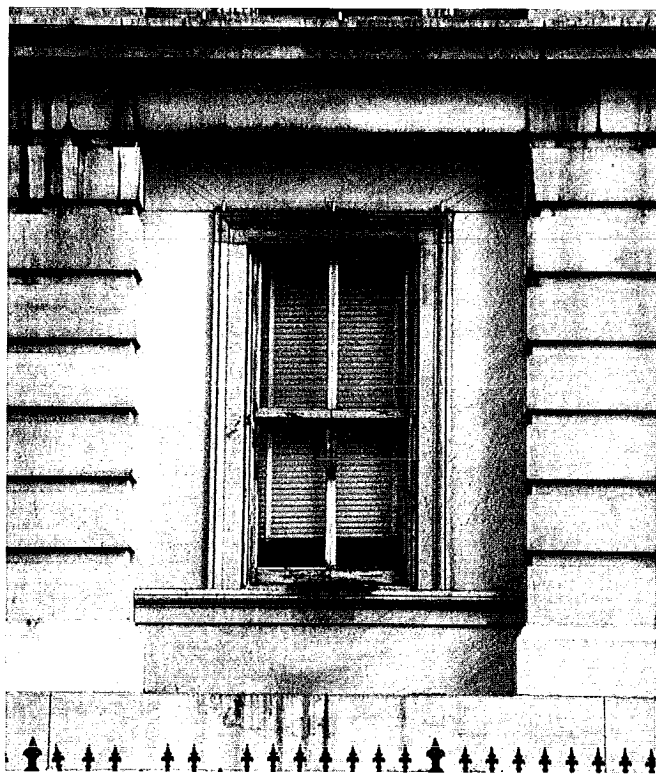
Fig. 10. Infiltration of damp air can occur around loose-fitting or deteriorated window sash and through cracks or open joints in building exteriors. Photo: Ann Brooks Prueher.

**Infiltration** is created by wind, temperature gradients (hot air rising), ventilation fan action, and the stack or chimney effect that draws air up into tall vertical spaces. Infiltration as a dynamic force does not actually move liquid water, but is the vehicle by which dampness, as a component of air, finds its way into building materials. Older buildings have a natural air exchange, generally from 1 to 4 changes per hour, which, in turn, may help control moisture by diluting moisture within a building. The tighter the building construction, however, the lower will be the infiltration rate and the natural circulation of air. In the process of infiltration, however, moisture that has entered the building and saturated materials can be drawn in and out of materials, thereby adding to the dampness in the air (see fig. 10). Inadequate air circulation where there is excessive moisture (i.e., in a damp basement), accelerates the deterioration of historic materials. To reduce the unwanted moisture that accompanies infiltration, it is best to incorporate maintenance and repair treatments to close joints and weatherstrip windows, while providing controlled air exchanges elsewhere. The worst approach is to seal the building so completely, while limiting fresh air intake, that the building cannot breathe.

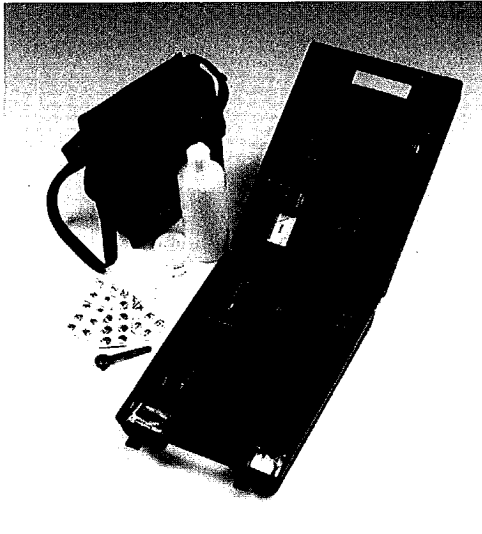
Fig. 14. Using instruments in this damp-check kit can help determine the relative change in wet conditions over time. This involves readings of air temperature, computing dewpoint temperatures, and tracking the moisture content of materials to indicate if they are drying properly. Photo: Dell Corporation.

If the owner or consultant has access to moisture survey and monitoring equipment such as resistance moisture meters, dewpoint indicators, salt detectors, infrared thermography systems, psychrometer, fiber-optic boroscopes, and miniaturized video cameras, additional quantified data can be incorporated into the survey (see fig. 15). If it is necessary to track the wetting and drying of walls over a period of time, deep probes set into walls and in the soil with connector cables to computerized data loggers or the use of long-term recording of hygrothermographs may require a trained specialist. Miniaturized fiber-optic video cameras can record the condition of subsurface drain lines without excavation (see fig. 16). It should be noted, however, that instrumentation, while extremely useful, cannot take the place of careful personal observation and analysis. Relying on instrumentation alone rarely will give the owner the information needed to fully diagnose a moisture problem.

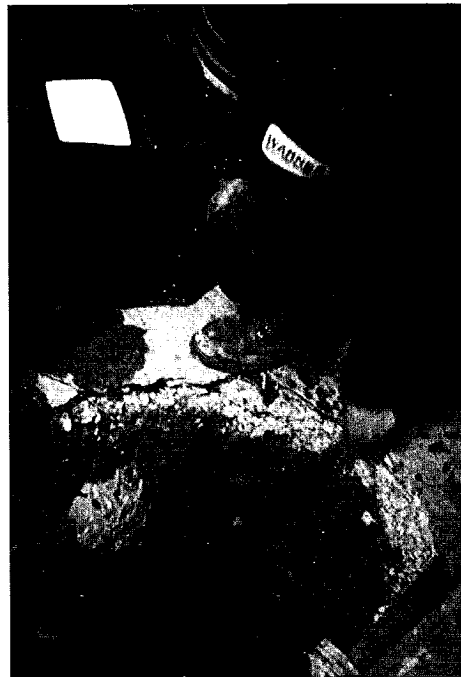
Fig. 16. Contractors specializing in building diagnostics often have video cameras or fiber optic equipment that allow the viewing of inaccessible areas. This is particularly helpful in chimney flues or subsurface drains, as shown here. In the past, these areas would need to be excavated for visual inspection. Photo: author.

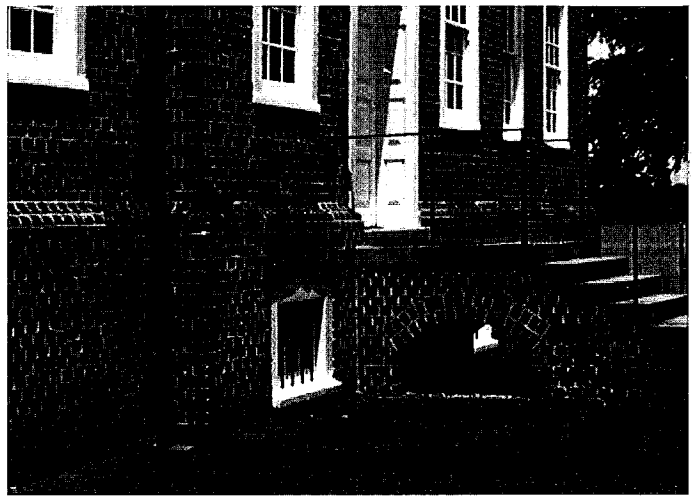
Fig. 17. In testing a theory for the cause of basement wetness, the owner used long black extender pipes to direct roof run-off away from the foundation. This test established that the owner did not need expensive waterproofing of the foundation, but a better drainage system. Photo: Baird M. Smith.

Once a hypothesis of the source or sources of the moisture has been developed from observation and recording of data, it is often useful to prove or disprove this hypothesis with interim treatments, and, if necessary, the additional use of instrumentation to verify conditions. For damp basements, test solutions can help determine the cause. For example, surface moisture in low spots should be redirected away from the foundation wall with regrading to determine if basement dampness improves. If there is still a problem, determine if subsurface downspout collection pipes or cast iron boots are not functioning properly. The above grade downspouts can be disconnected and attached to long, flexible extender pipes and redirected away from the foundation (see fig. 17). If, after a heavy rain or a simulation using a hose, there is no improvement, look for additional ground moisture sources such as high water tables, hidden cisterns, or leaking water service lines as a cause of moisture in the basement. New data will lead to a new hypothesis that should be tested and verified. *The process of elimination can be frustrating, but is required if a systematic method of diagnosis is to be successful.*

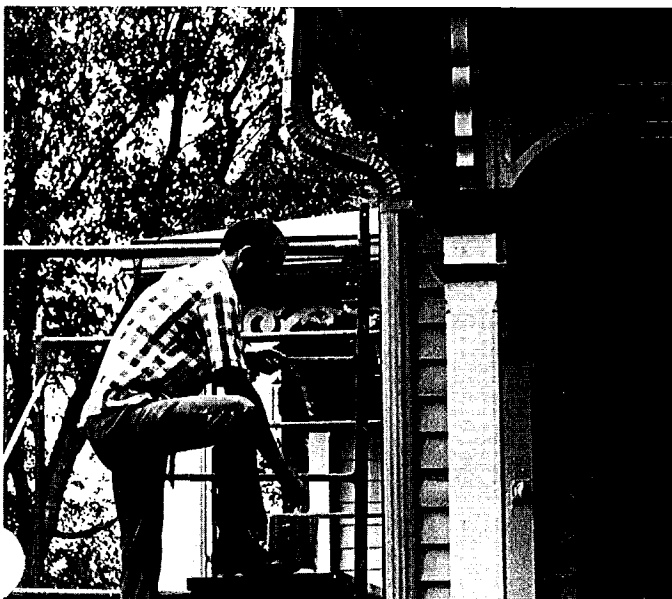
Fig. 19. Maintaining gutters and downspouts in good operable condition, repairing exteriors to keep water out, redirecting damaging moisture away from foundations and controlling interior moisture and condensation are all important when holding the line on moisture deterioration. Photo: Nebraska State Historical Society.

Once the building has been repaired and the larger moisture issues addressed, it is important to keep a record of additional evidence of moisture problems and to *protect the historic or old building through proper cyclical maintenance* (see fig. 19). In some cases, particularly in museum environments, it is critical to monitor areas vulnerable to moisture damage. In a number of historic buildings, in-wall moisture monitors are used to ensure that the moisture purposely generated to keep relative humidity at ranges appropriate to a museum collection does not migrate into walls and cause deterioration. The potential problem with all systems is the failure of controls, valves, and panels over time. Back-up systems, warning devices, properly trained staff and an emergency plan will help control damage if there is a system failure.

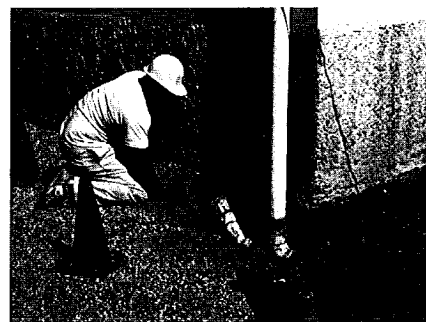
C. Cleaning out gutters and downspouts should be done at least twice a year. Photo: WPTC, NPS.

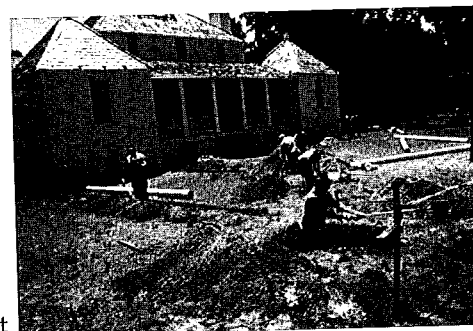
C. Develop new drainage systems for roof run-off that remove moisture from the base of the building. Photo: WPTC, NPS.

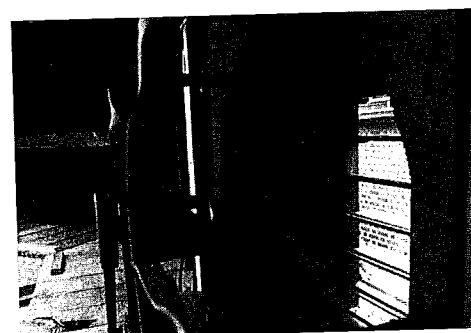
D. Install ventilating fans when additional air circulation will improve damp conditions in buildings or reduce cooling loads. Photo: Ernest A. Conrad, P. E.

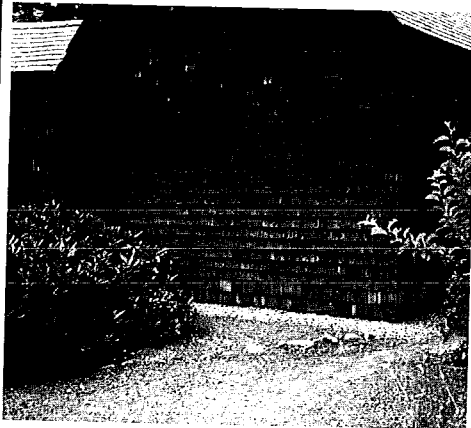
C. The new ground gutter gravel base helps drainage around the concrete foundation (see B above) which is not visible behind the replaced wooden wall shingles. Photo: WPTC, NPS.

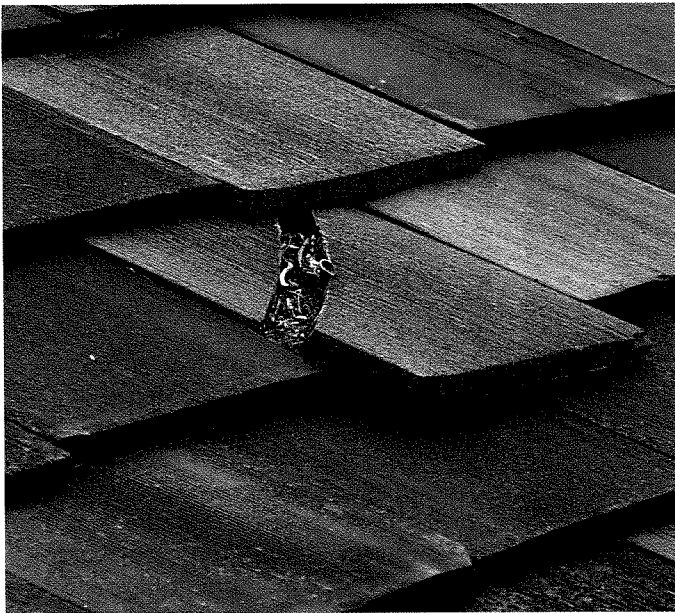
*Figure 4. Damage to roofs often requires immediate attention. As a temporary measure, this damaged roof tile could be replaced with a brown aluminum sheet wedged between the existing tiles. Photo: Chad Randl.*

- As a temporary measure, slip pieces of non-corrosive metal flashing under or between damaged and missing roofing units until new slate, shingles, or tile can be attached. Repair broken, missing or damaged roofing units with ones that match. Follow roofing supplier and industry guidance on inserting and attaching replacement units (Fig 4). Avoid using temporary asphalt patches as it makes a proper repair difficult later on.

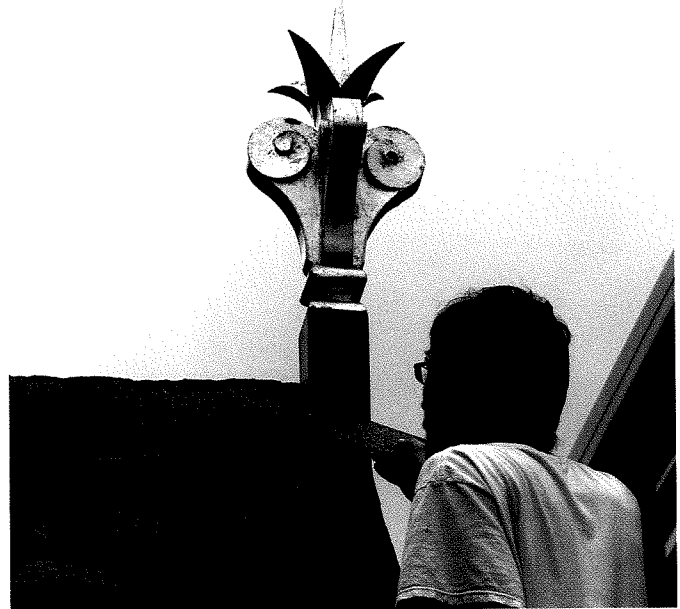
*Figure 5. The use of a sealant to close an exposed joint is not always an effective long-term solution. Where this decorative wood element connects to the slate roof, the sealant has failed within a short time and a proper metal flashing collar is being fitted instead. Photo: Bryan Blundell.*

- Re-secure loose decorative elements, such as finials and weathervanes. Seek professional advice if decorative elements exhibit considerable corrosion, wood rot, or structural instability. Small surface cracks may benefit from a flexible sealant to keep moisture out; sealants have a limited life and require careful inspection and periodic replacement (Fig 5).

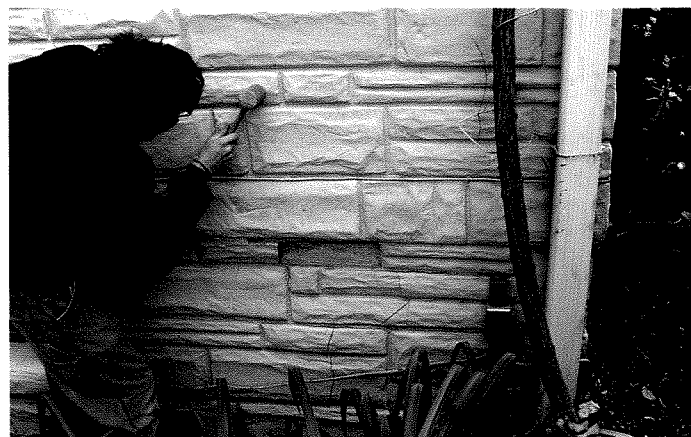
*Figure 6. Stucco applied to an exterior wall or foundation was intended to function as a watertight surface. Unless maintained, rainwater will penetrate open joints and cracks that may occur over time. A spalled section of stucco indicates some damage has occurred and a wooden mallet is being used to tap the surface to determine whether the immediate stucco has lost adhesion. Photo: Bryan Blundell.*

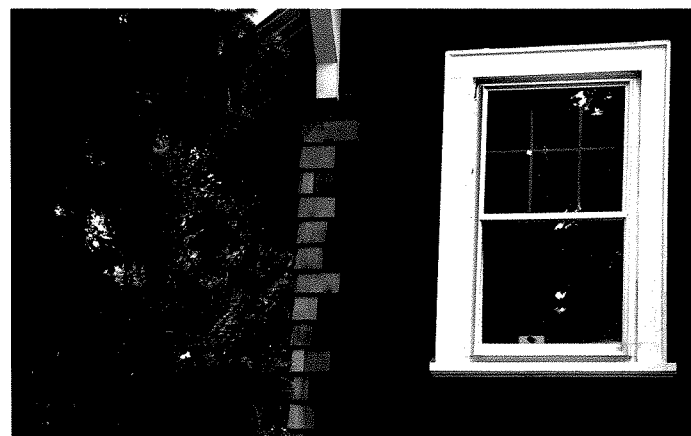
*Figure 7. One of the advantages of wood shingles as a wall covering is that individual shingles that are damaged can easily be replaced. On this highly exposed corner, worn shingles have been selectively replaced to help safeguard against water damage. The new shingles will be stained to match the existing shingles.*

or cracks indicative of potential structural problems, seek professional guidance as to the cause of distress and appropriate corrective measures. Wood-frame construction generally will require more frequent maintenance than buildings constructed of brick, stone, or terra cotta (Fig 7).

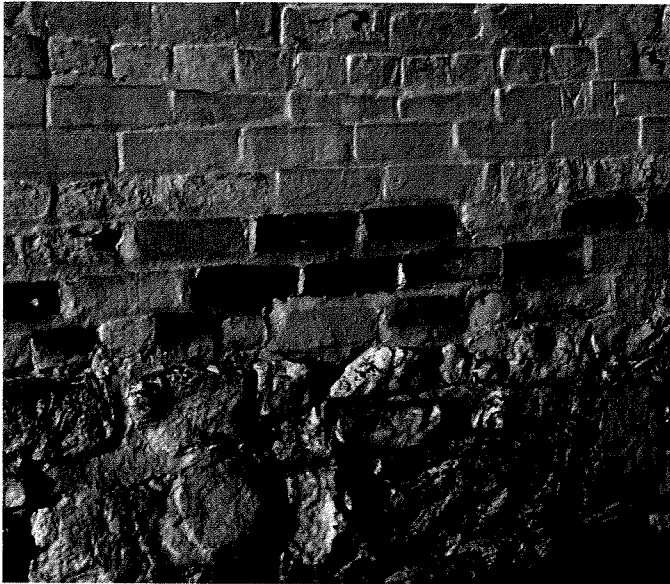
*Figure 10. Repointing of masonry should usually be approached as repair rather than maintenance work in part because of the need for a skilled mason familiar with historic mortar. In this case, a moisture condition was not corrected and the use of a waterproof coating and off-the-shelf Portland cement mortar trapped water and resulted in further damage to these 19th century bricks. Photo: NPS files.*

mortar on vertical masonry wall surfaces, as they are not breathable and can lead to moisture-related damage of the adjacent masonry (Fig 10).

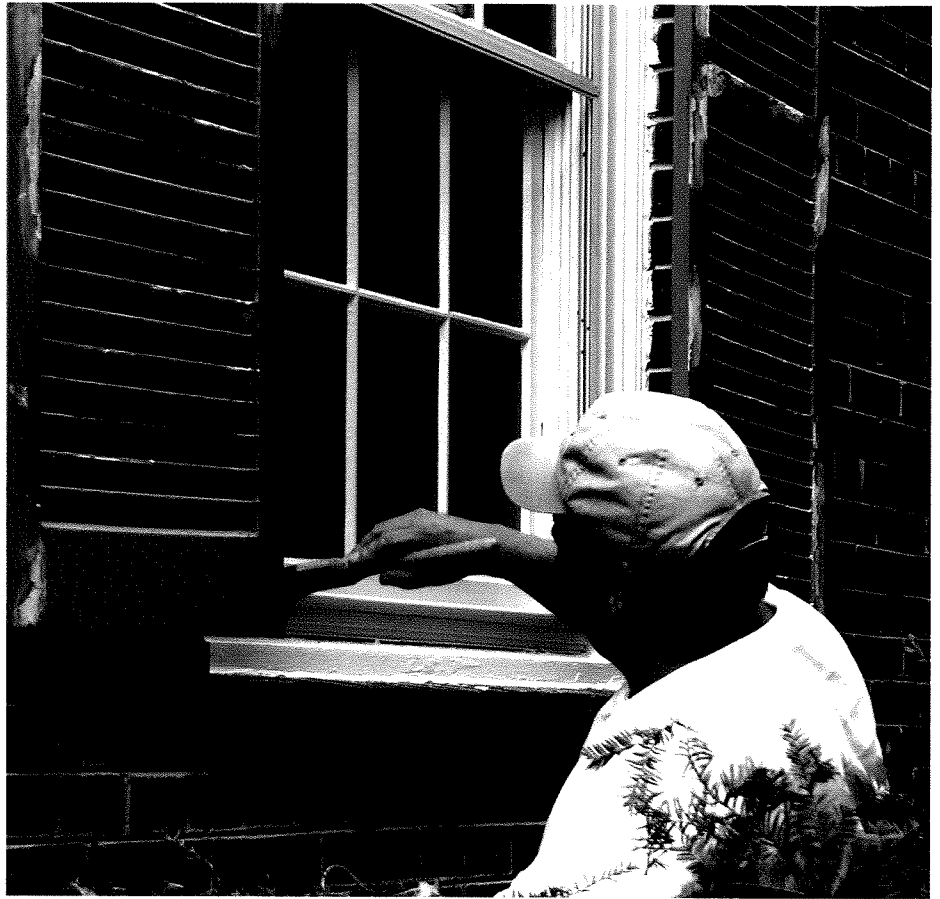
*Figure 12. Good surface preparation is essential for long lasting paint. Scraping loose paint, filling nail holes and cracks, sanding, and wiping with a damp cloth prior to repainting are all important steps whether touching up small areas or repainting an entire feature. Always use a manufacturer's best quality paint. Windows and shutters may need repainting every five to seven years, depending on exposure and climate.*

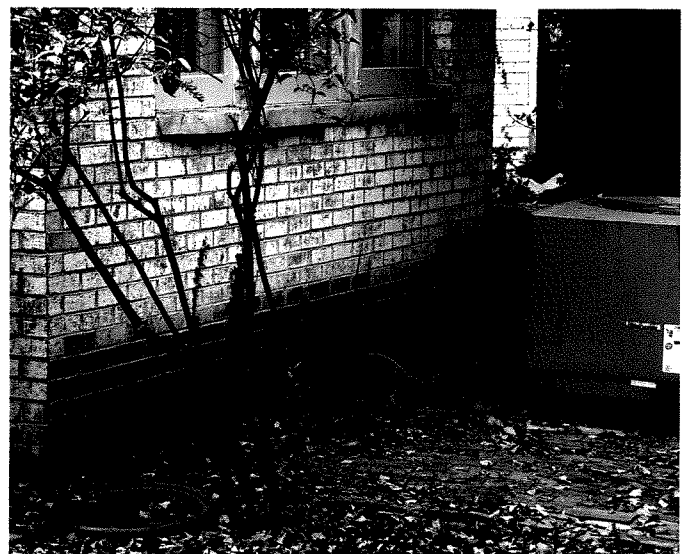
Figure 16. This chronically wet area has a mildew bloom brought on by heat generated from the air-conditioning condenser unit. The dampness could be caused by a clogged roof gutter, improper grading, or a leaking hose bibb.

- material deterioration at or near the foundation, including loss of mortar in masonry, rotting wood clapboards, or settlement cracks in the lower sections of wall;
- evidence of animal or pest infestation;
- vegetation growing close to the foundation, including trees, shrubs and planting beds;
- evidence of moisture damage from lawn and garden in-ground sprinkler systems;
- evidence of moss or mold from damp conditions or poorly situated downspout splash blocks (Fig 16); and
- blocked downspout drainage boots or clogged areaway grates.

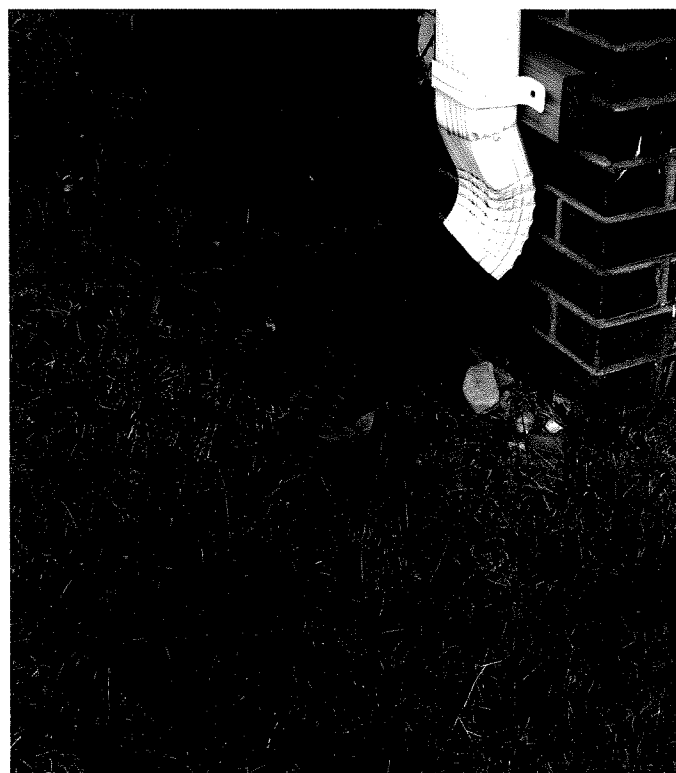
*Figure 17. Extending downspouts at their base is one of the basic steps to reduce dampness in basements, crawl spaces and around foundations. Extensions should be buried, if possible, for aesthetics, ease of lawn care, and to avoid creating a tripping hazard. Photo: NPS files.*

- Reset splash blocks at the end of downspouts or add extender tubes to the end of downspouts as necessary (Fig 17).
- Lubricate operable foundation vent grilles to facilitate seasonal use; paint as needed.

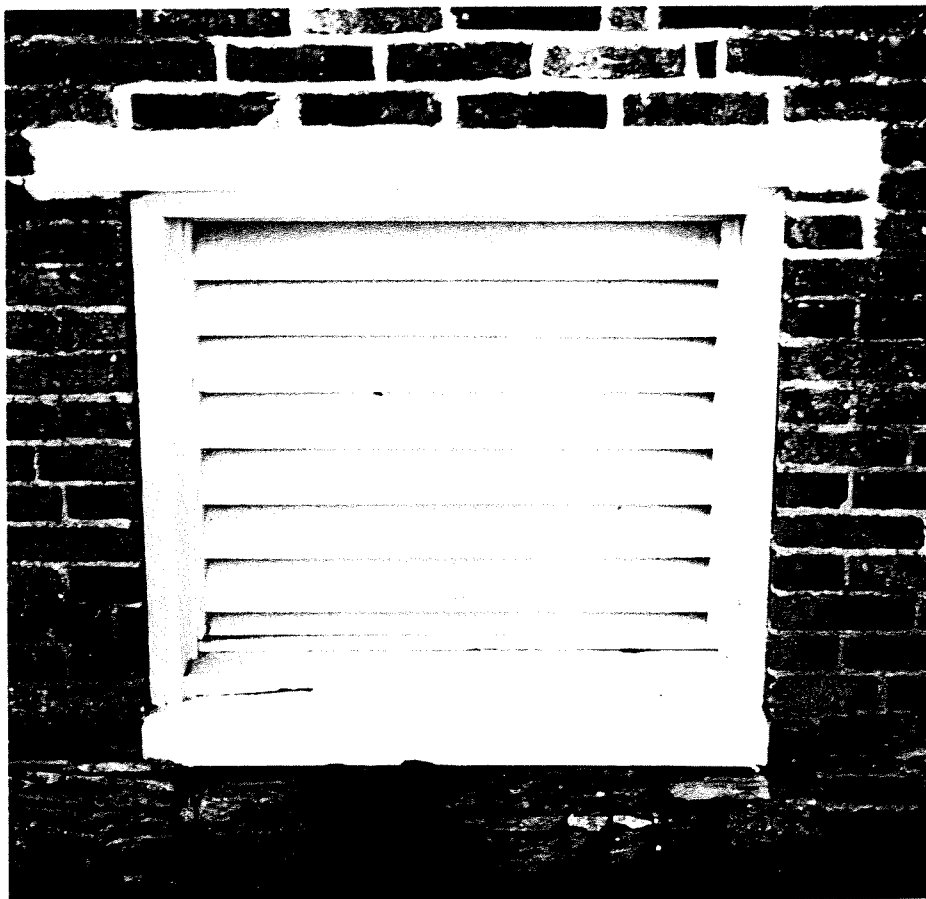
**Figure 3.** The exposed edges of the louver slats were plumb cut in order to create a water drip on the exterior. For aesthetic reasons, the louvers were painted the same color as the sash and trim. Photo: Charles Fisher

In order to secure the vents in place, common 6d galvanized box nails were driven through the louver jambs into the sash tracks of the historic window jambs. To keep the jamb and stops from being damaged by the louver installation, temporary blocking was set between the parting bead and the inner and outer stops (see figure 4). By attaching the vents in this location, little damage was done as the nails were driven into the sash track rather than an exposed portion of the jamb. Once the building is returned to use, the lower sash will be installed and the nail holes will be filled with wood putty. Since the nails were driven in on the interior of the building, nearly 3" from the exterior wall, adequate security was achieved without driving the nails all the way in. Thus it will be relatively easy to grab onto the nail heads and back them out when the vents are eventually removed.

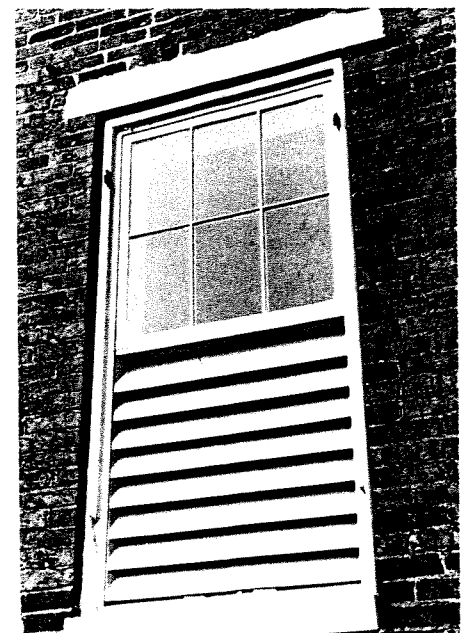
**Figure 2.** Section of the wooden louvers shows the simple manner in which they were made and assembled. Drawing: Thomas Vitanza

The louver frame was designed to fit snugly into the existing sash tracks and simultaneously to secure the glazed upper sash. An added benefit of the 6" stock width is that it provided a fairly rigid — and thus secure — louver frame. The louver frame was constructed of 1" x 6" shelf grade northeastern white pine; the louver slats were

made from 1" x 8" pine (see figure 2). The spacing of the louver slats did not exceed 4" in order to provide additional lateral strength (and security) to the frame. The relative closeness of the slats also would make it more difficult to kick out the grade level units. The slats were set into the frame at a 45 degree angle by routing a 1/4" deep dado

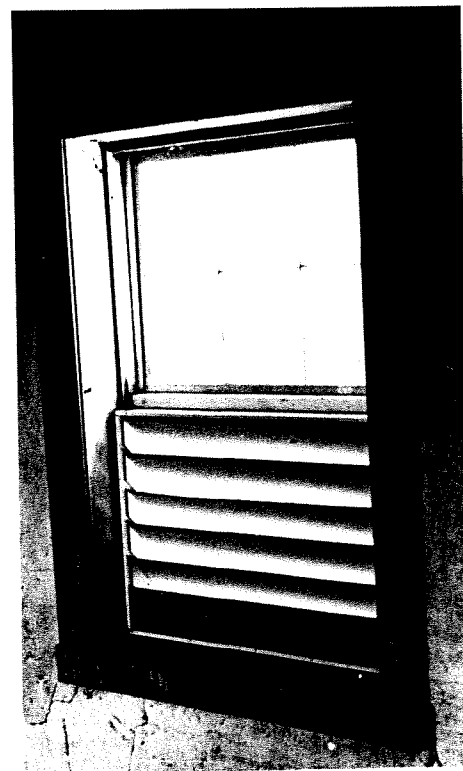
**Figure 5. Screening was attached to the back side of the louvers to prevent the recurrence of insect, bird, and rodent infestation. Photo: Charles Fisher**

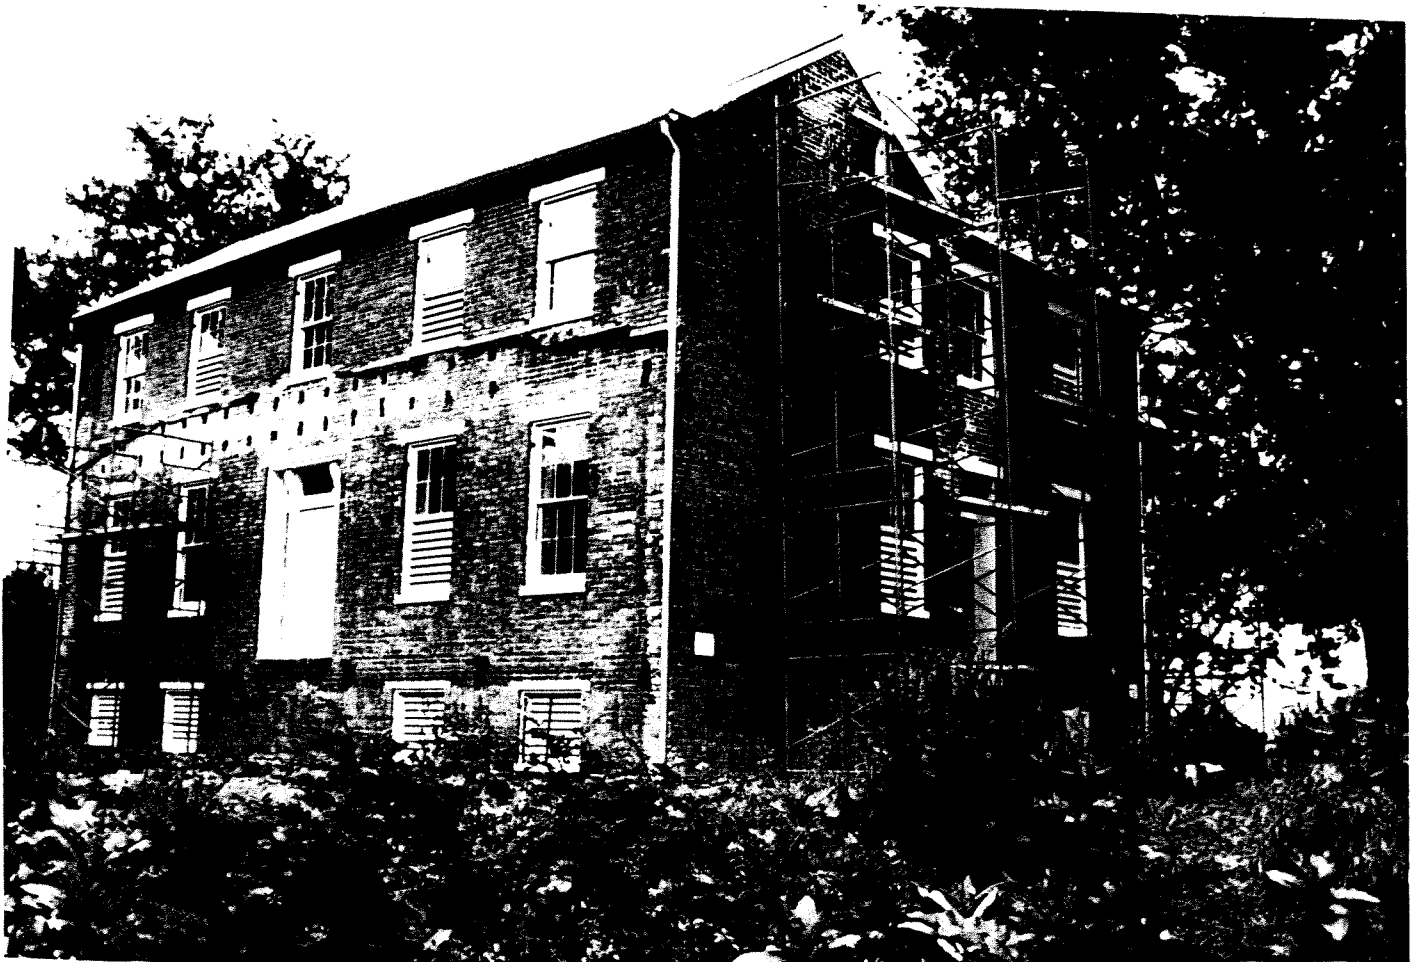
**Figure 6. The window louvers installed in the Worthington House have proven effective over the past two years in providing the necessary ventilation for the building. Photo: Tom Vitanza.**

The window louvers installed in the Worthington House have proven effective over the past two years in providing the necessary ventilation for the building (see figure 6). Neither fungal attack nor condensation damage has recurred, and the interior air lacks even the typically humid, musty odor typically found in many older buildings. The louvers provide for good air movement within the building and a greater equilibrium between interior and exterior humidity levels and air temperatures, thus helping to protect the historic plaster and the significant interior finishes. The installation of the louver system in conjunction with the other sash work, and the overall exterior stabilization work has stimulated an interest in finding a use for the structure. As a temporary solution to a complex set of problems, the louver vents in the Worthington House have resolved a variety of issues. When used together with additional weatherproofing measures, this venting solution can be adopted for use in other buildings being mothballed.
